# Manhole Inspection Summary

Manhole # S29M\_\_029MH

Insp Date: **12/8/08 9:27 AM**

**Location** Address: **807 W.Barre St.**

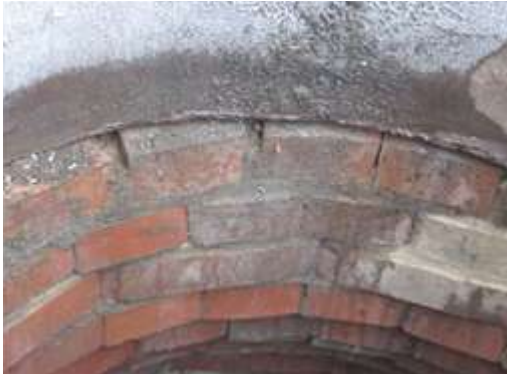
Defect 3

☒ **Loose Brick**

☒ **Mortar**

missing mortar with infiltration at chimney

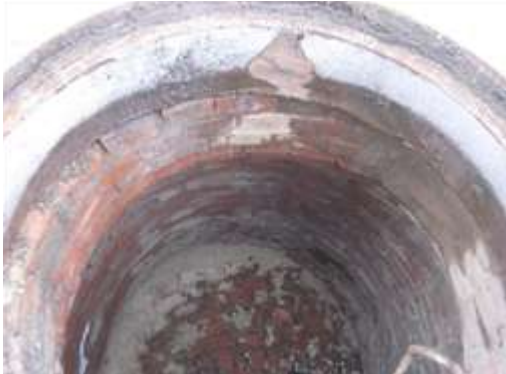
Defect 2

☒ **Leaks**

☒ **Cracked**

frame & chimney infiltration

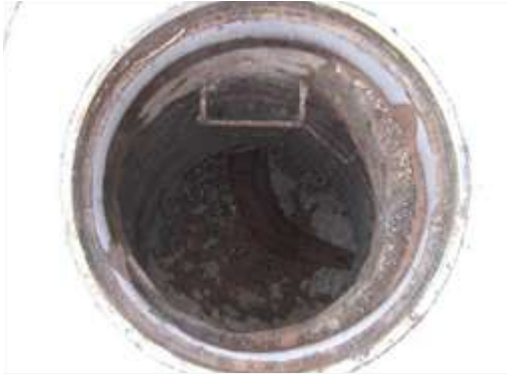
Defect 1

Offset: **3** (in.)

☒ **Cracked**

frame offset and broken frame

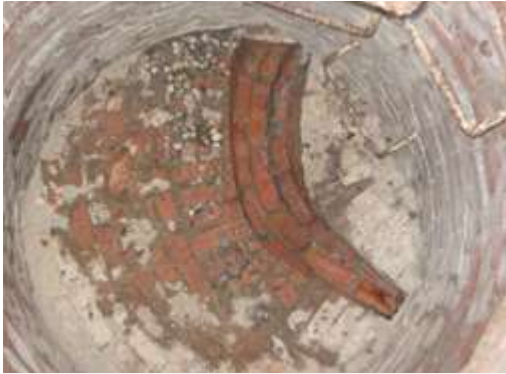
defect

☒ **Corroded**

corroded steps

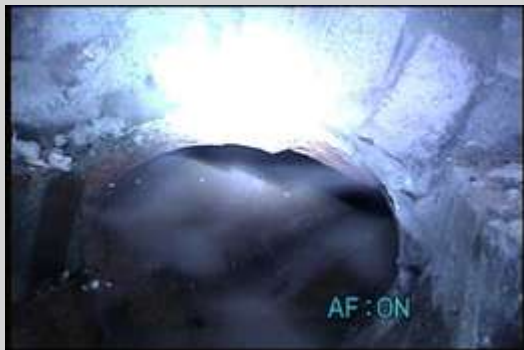
12 O'Clock Outflow

8 in. Circular Gravity Sewer  
Pipe Out @ 12 O'Clock

Infiltration: **None** Pipe Seal Cond: **Sound**

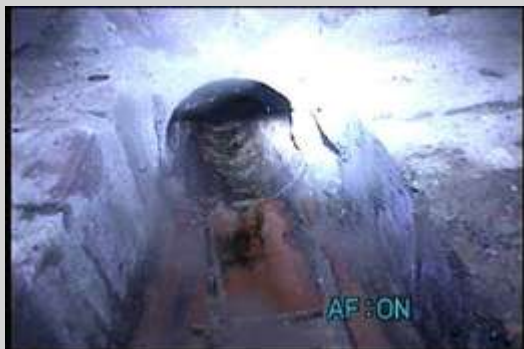
4 O'Clock Inflow

4 in. Circular Gravity Sewer  
Pipe In @ 4 O'Clock

Infiltration: **None** Pipe Seal Cond: **Sound**
